ISO 80369-3 ENFIT design details create a dangerous misconnection

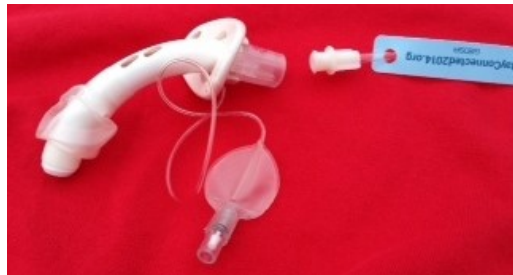
Shiley adult tracheostomy tube with 15mm fitting-connector and female administration set supplied by GEDSA, shown not connected.

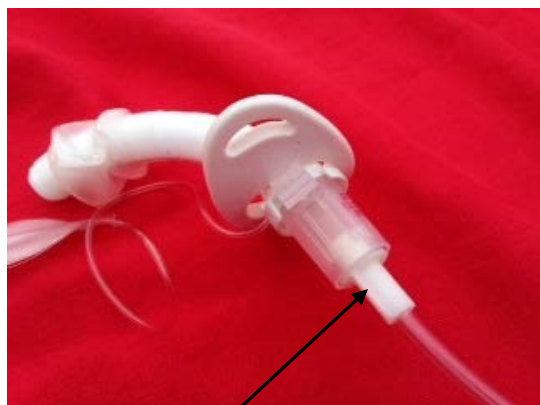
*Shiley adult tracheostomy tube with 15mm fitting-connector and female administration set supplied by GEDSA, **shown connected** in a wedge-lock fit, thereby compromising safety.*

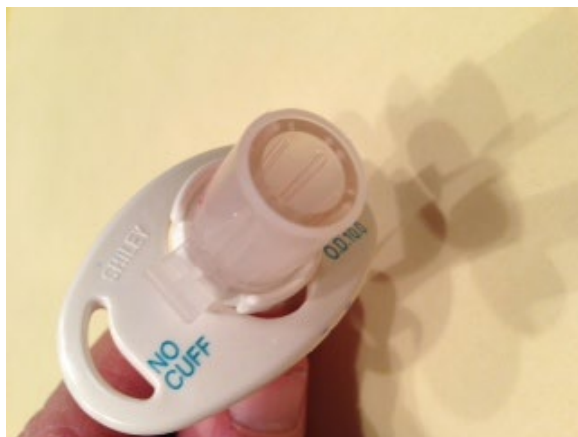
Showing a Shiley 15 mm tube cannula connector.

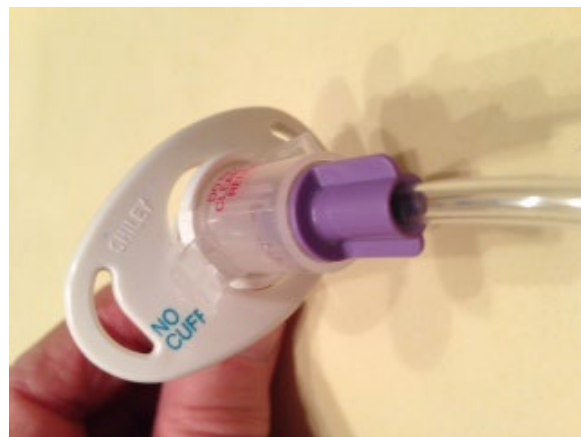
These photos shows a true misconnection fit between 80369-3 enteral female and tracheostomy tube cannula connector.

Showing a 80369-3 female connector misconnecting with a Shiley 15 mm tube cannula connector.
